National Dam Safety Program. Township  
Line Dam (NDI-Pa-475), Ohio River Basin,  
Township Line Run, Westmoreland County,  
Pennsylvania. Phase I Inspection Report.

## PHASE I REPORT National Dam Inspection Program

Township Line Dam

PHASE I INSPECTION REPORT  
NATIONAL DAM INSPECTION PROGRAM  
TOWNSHIP LINE DAM  
NDI# PA-475, PENNDR# 65-33

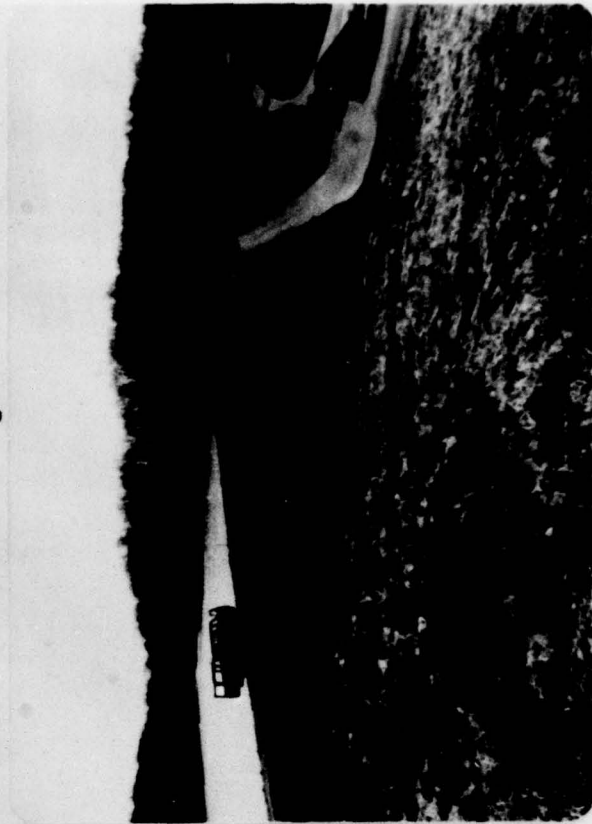
PHOTOGRAPH 7 View showing the downstream portion of the Township Line embankment. Note the dark areas near the toe of the embankment. They are shallow depressions where sloughing has occurred.

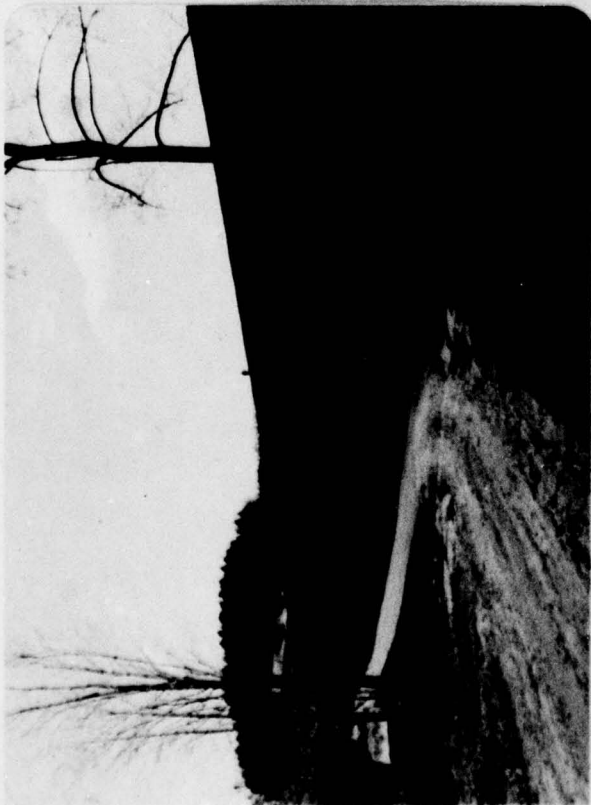
PHOTOGRAPH 8 View of the downstream portion of the embankment taken from the area just downstream of the left abutment. The stone structure in the left portion of the photograph is an abandoned pumphouse (pump, valves, etc., have been removed).

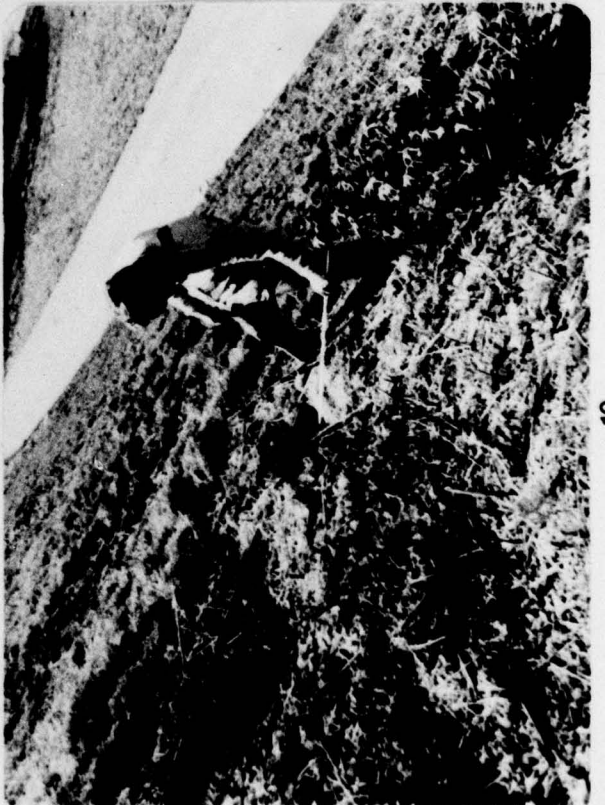
a. Embankment. The downstream slope of the dam is relatively steep (1.5H to 1V). Seepage was observed to be issuing from two points near the toe of the embankment where the phreatic surface apparently intersects the downstream slope. Many rodent holes were present in the lower half of the downstream face and water was encountered in one of the holes located approximately 15 feet above the dam toe at a depth of about 1-1/2 feet (see Photographs 10, 11, and 12).

PHOTOGRAPH 10 View of one of the numerous rodent holes on the downstream slope of the embankment. The pipe in the photograph is probably an abandoned aeration line.

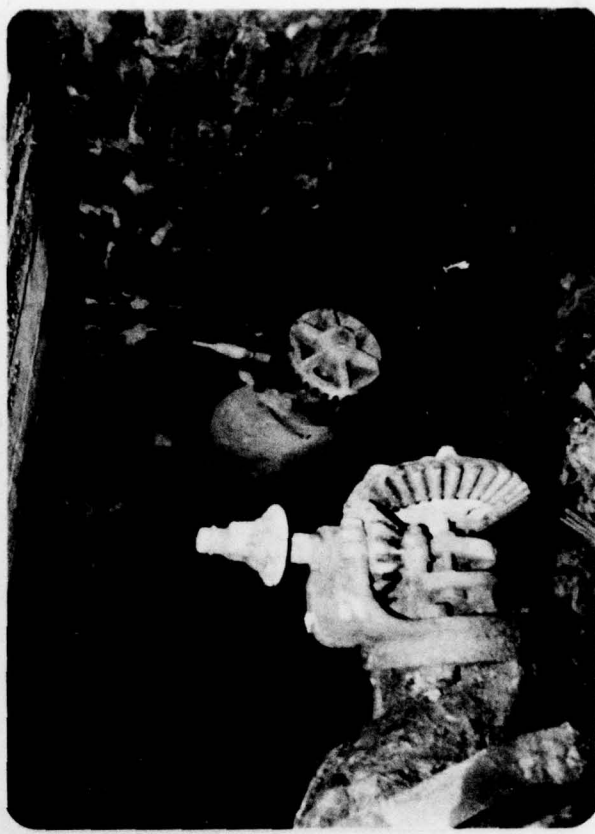
PHOTOGRAPH 15 View of the manhole just downstream of the Township Line embankment. Within this manhole are three valves previously used to control the flow in the supply line of Township Line Run Reservoir as well as direction of flow of water from Immel Reservoir.

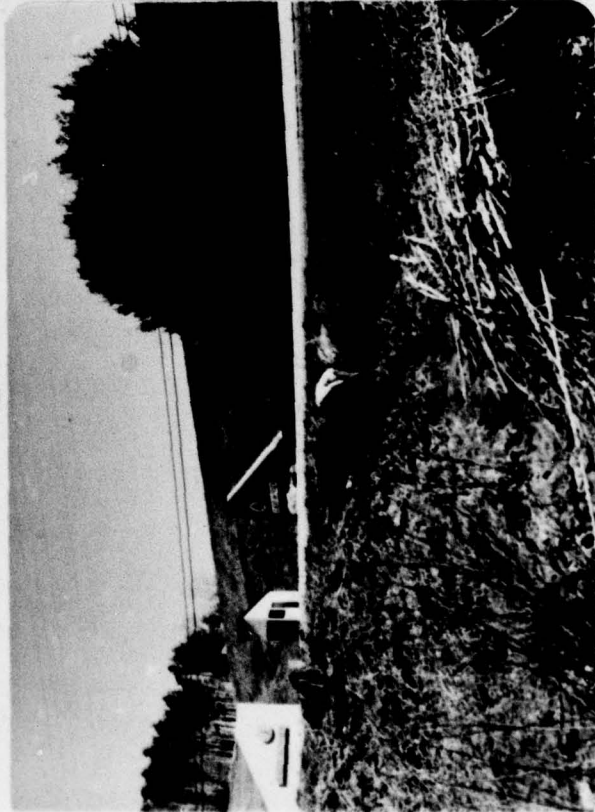
PHOTOGRAPH 14 View from swampy area downstream of the Township Line Dam. Water was discharging through a 12-inch corrugated metal pipe at this location, however, the inlet end of this pipe was dry and the source of the flow could not be determined.

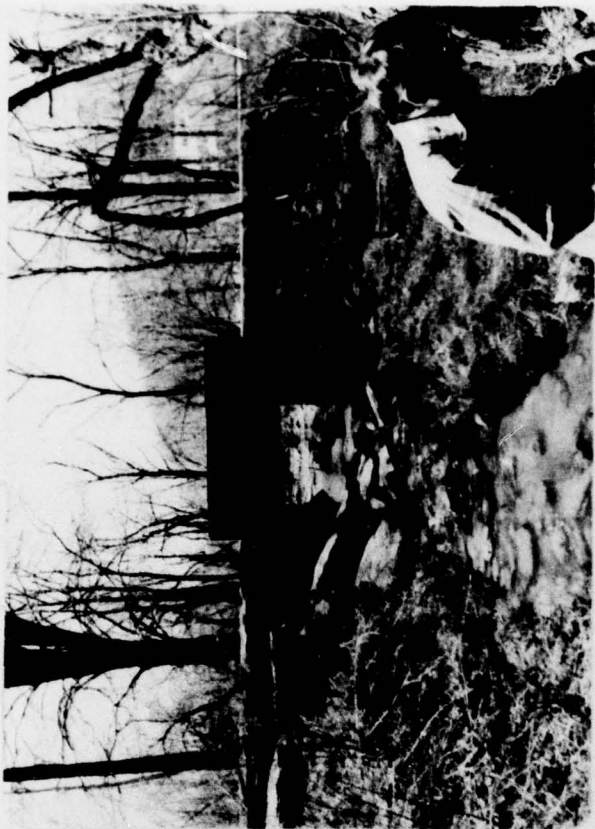
PHOTOGRAPH 17 View of two-lane bridge approximately one mile downstream of the Township Line Dam. The bridge is the first downstream improvement beyond the barn located near the toe of the Township Line Dam. Note the housing development visible in the upper right corner. The two lowest houses in the development are considered hazard prone.
